ALIDECK ALUMINIUM DECKING

Balcony board

BS 7976

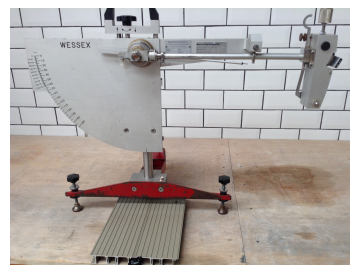
Direction A: Direction of traffic ; B: 90 Degrees ; C: 45 Degrees

DIR' N	CONT' N				1	2	3	4	5	MEAN	PREV	RISK
A	DRY	100	100	100	100	100	100	100	100	100	0	Low
A	WET	100	100	100	100	100	100	100	100	100	0	Low
B	DRY	51	50	49	49	49	49	49	49	49	0	Low
B	WET	36	35	36	35	35	34	35	35	35	0	Med
C	DRY	51	50	50	50	49	49	49	49	49	0	Low
C	WET	45	45	44	44	44	44	44	44	44	0	Low

No further action is required as the surface is suitably rough / profiled / conditioned to provide adequate levels of grip in wet conditions. The average PTV of the surface is equal to or greater than 36 which classifies the area as Low Risk.
